201-MHz NCRF Cavity Program

Derun Li
Center for Beam Physics
Lawrence Berkeley National Laboratory

Neutrino Factory & Muon Collider
Collaboration Meeting
March 12 ~ 15, 2006

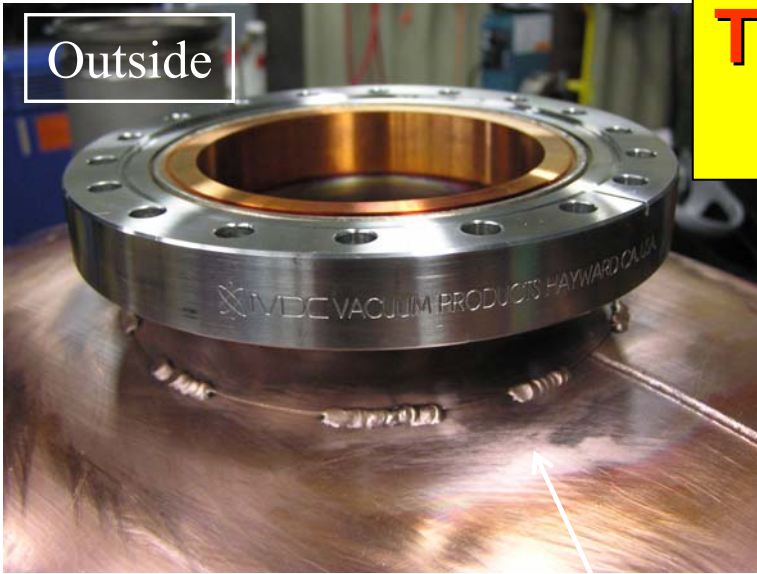
Outside

- ✓ cavity body
- ✓ cooling tube
- ✓ ports and flanges
- ✓ leak tight

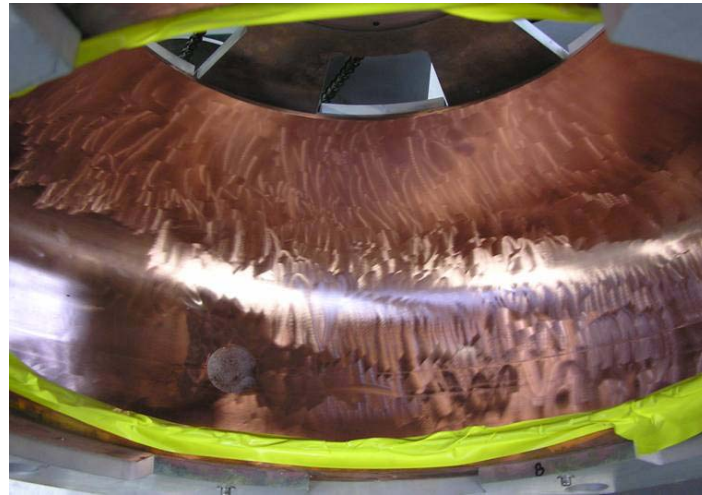
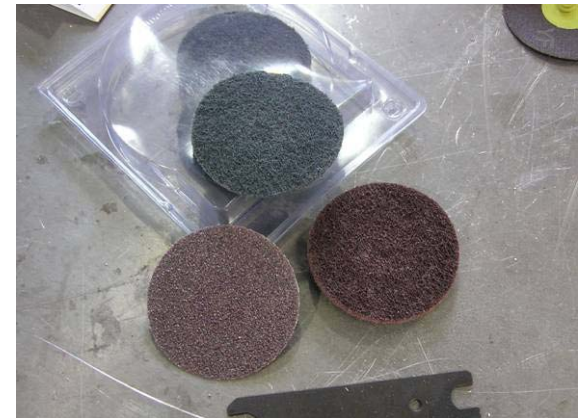
Cavity Progress: Final Interior Buffing

- Final interior buffing of cavity is performed to ensure the surfaces are ready for electropolishing
- Less buffing needed near equator where fields are lower
- An automated process of buffing was developed using a rotary buffing wheel and a cavity rotation fixture
- Some local hand work required to clean up some areas
- A series of pads with graduated coarseness was used
- Goal was scratch depth shallow enough for EP removal

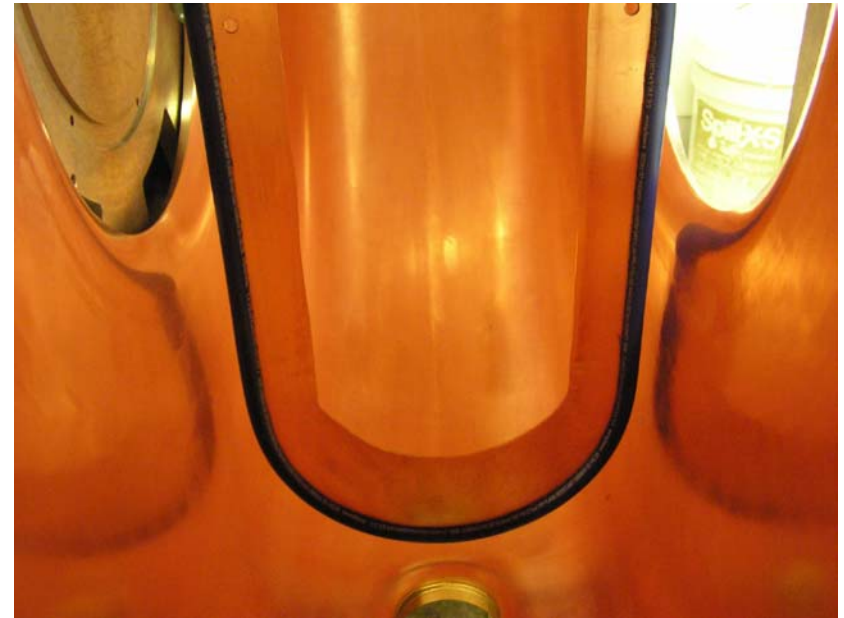
Cavity Progress: EP Setup

EP setup and the U-shape
electrode for EP at J-Lab

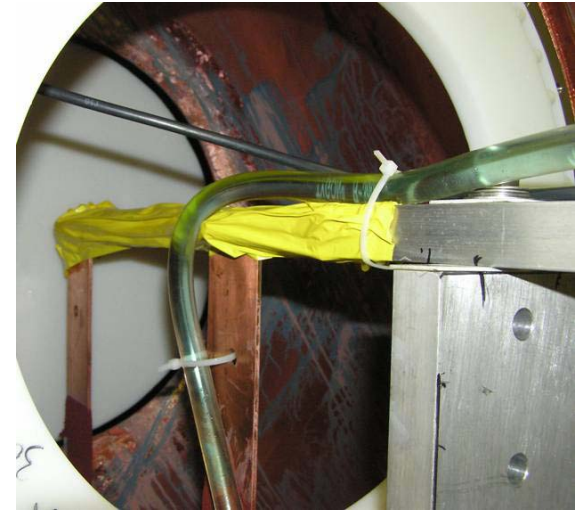
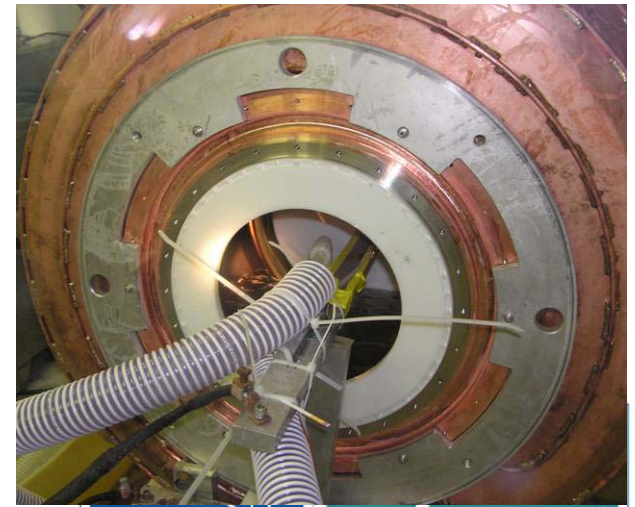
Interior Surface Electropolish

- After buffing, cavity underwent a chemical cleaning process
- Test bars with various degrees of buffing were run through an electropolish process
- Cavity was rotated with a U-shaped electrode fixed in place
- Initial polish failed due to depletion of the solution, and rebuffering was required
- 2nd EP successfully removed scratches in high field regions
- Final process is a high pressure water rinse of cavity surface

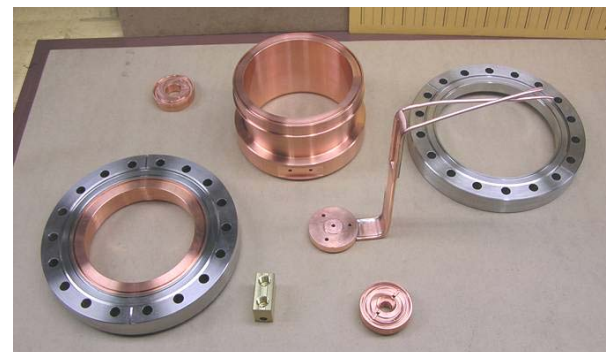
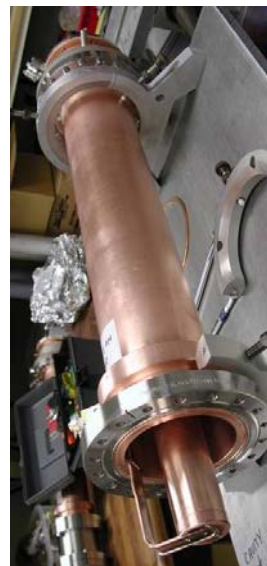
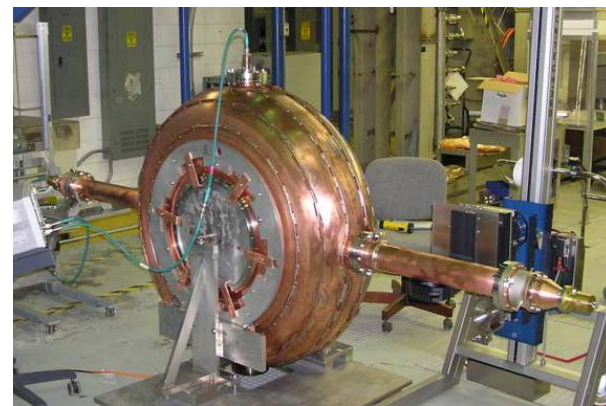
Cavity RF Couplers and Assembly

- Coupling loops were fabricated using standard copper co-ax
- Most coupler parts were joined by torch brazing – vacuum leaks were found in two of the outer conductor joints
- Coupling loop contains an integrated cooling tube
- The coupler was designed to mate with an SNS style RF window manufactured by Toshiba
- High power conditioning performed at SNS (ORNL)

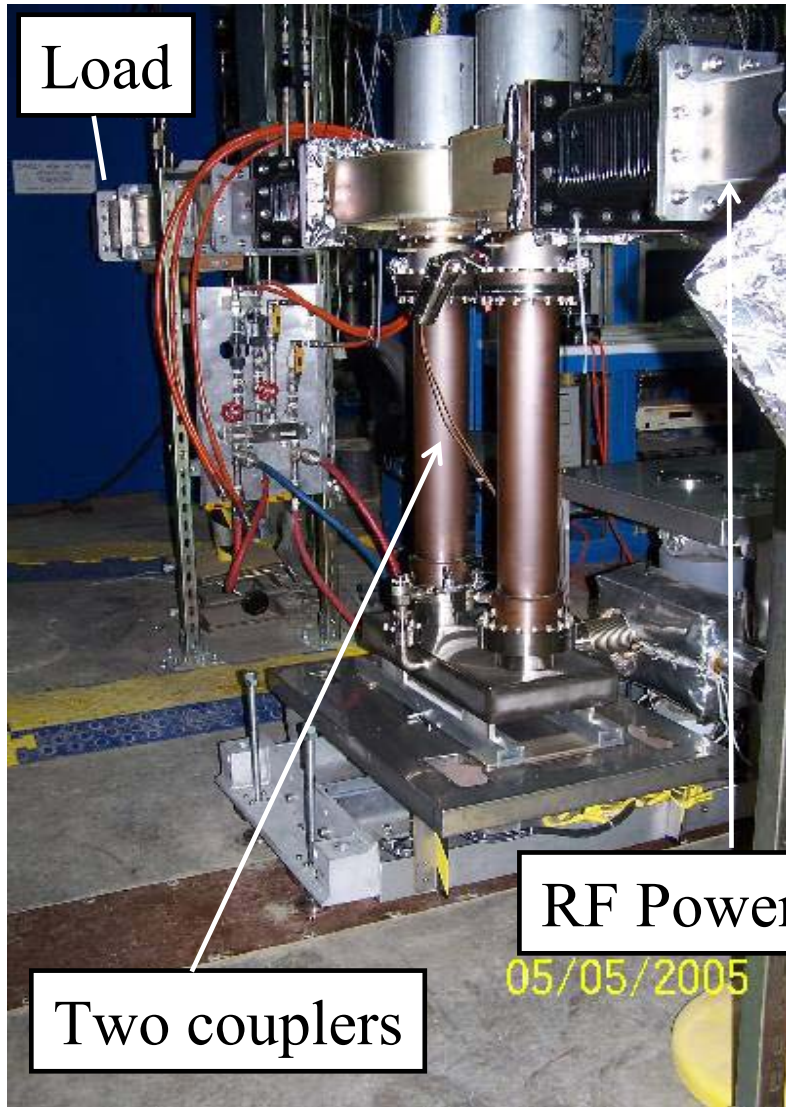
Coupler Conditioning

Two loop couplers

- Conditioning started during PAC-05 week at SNS, ORNL
- Good vacuum \sim low 10^{-8} T
- Achieved **600 kW** in TW mode (matched load)
- Achieved **10 kW average power** (\sim 9 kW for nominal NF parameters)
- Achieved **2.4 MW peak power** in SW mode (at variable short positions)
- Ceramic windows work perfectly within two weeks of the conditioning

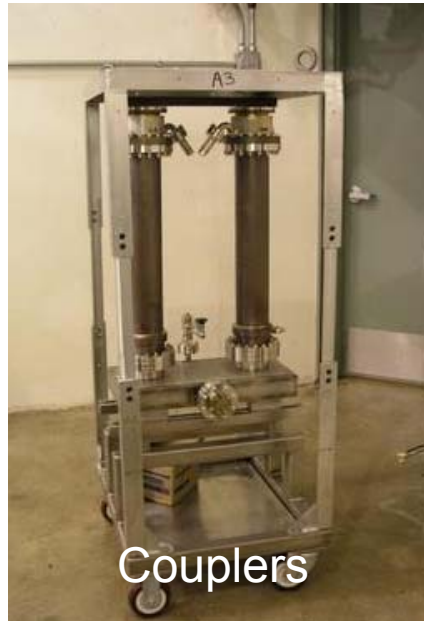
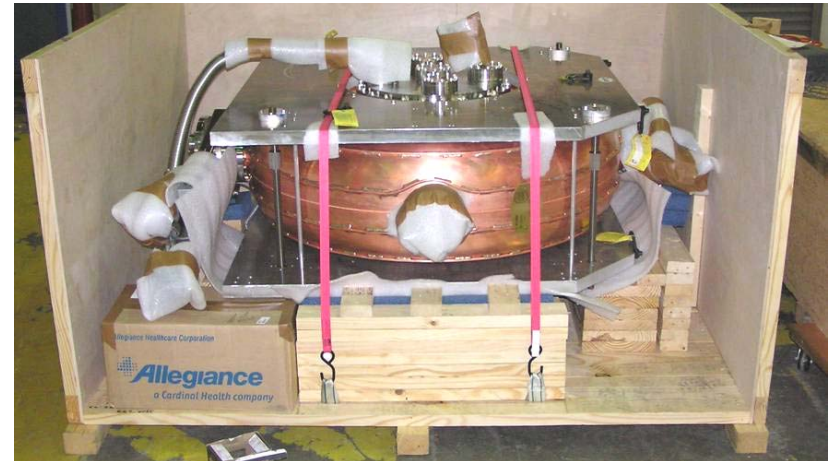
Shipment to the MTA at FNAL

- System assembly included: tuner plates, port blank-offs, diagnostic spool, window cover plates, gate valve and window pump-out tubes
- Final leak check conducted prior to shipping
- Cavity was back-filled with nitrogen in its assembled state and packaged in a custom made crate for shipping to the MTA

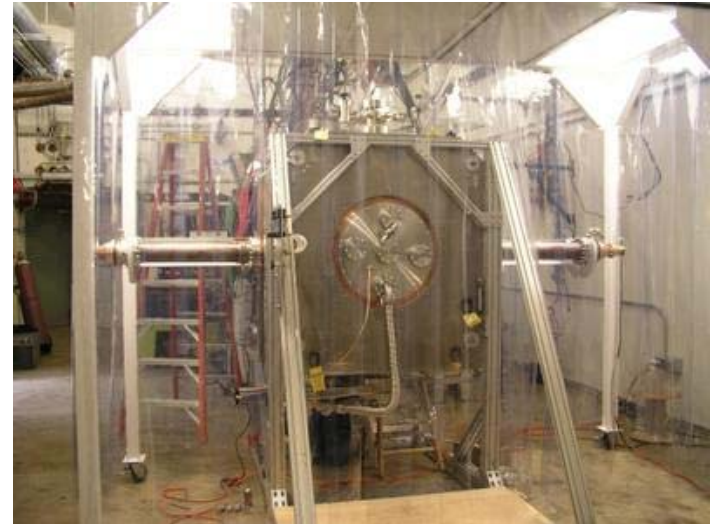
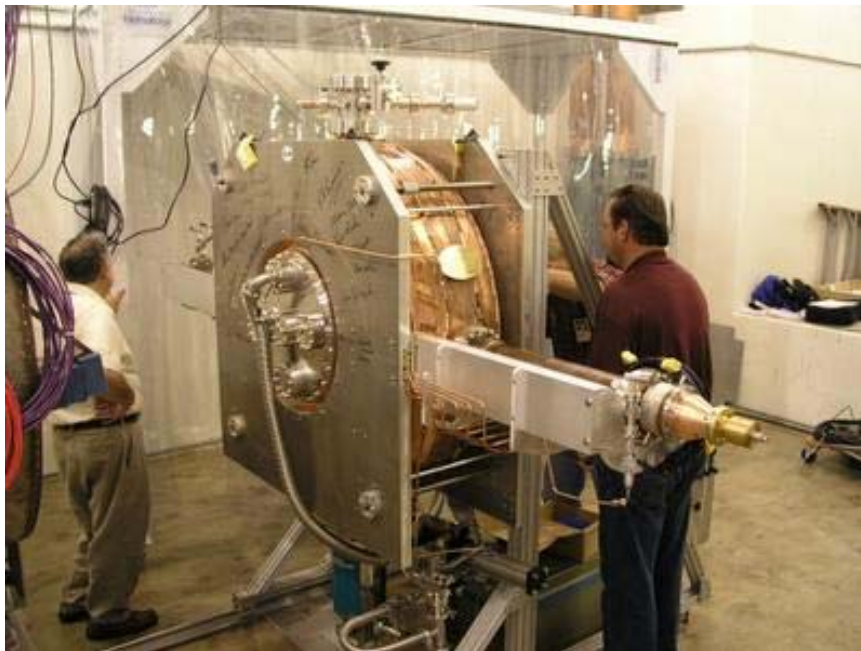
Low Power Measurements

$f = 199.578$ MHz

$Q_0 = 49,000 \sim 51,000$ (better than 90% of the design value)

Two couplers

- balanced
- coupling adjustments

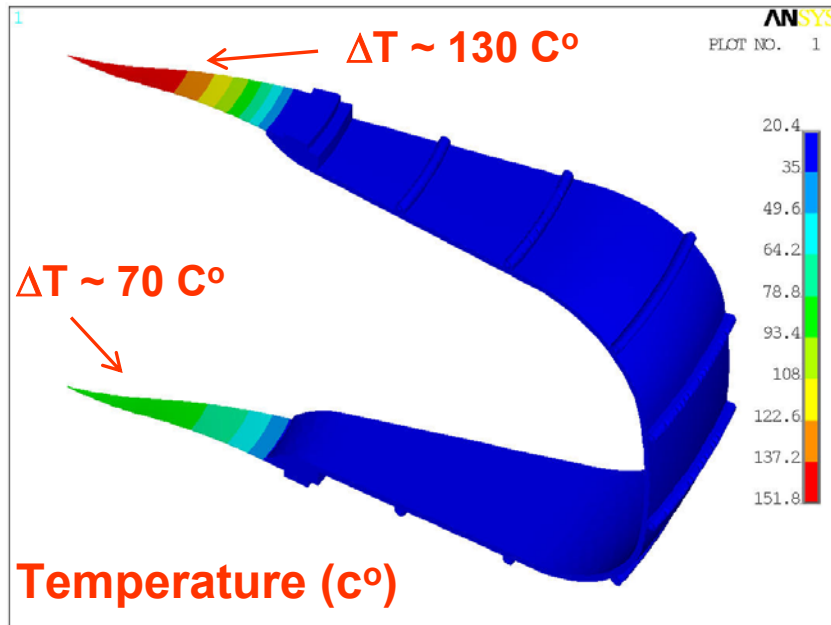
Asymmetric RF Heating (cont'd)

• ANSYS simulations

- A 15° slice cavity model
- Solve for RF fields
- 8.4 kW average heating power
- 20 C° water cooling
- Heat flux and temperature distribution
- Stress and displacement
- Frequency shifts

Frequency shift: 94 kHz (RT to FP)

- Cavity body expansion (small)
- Window displacement (major)

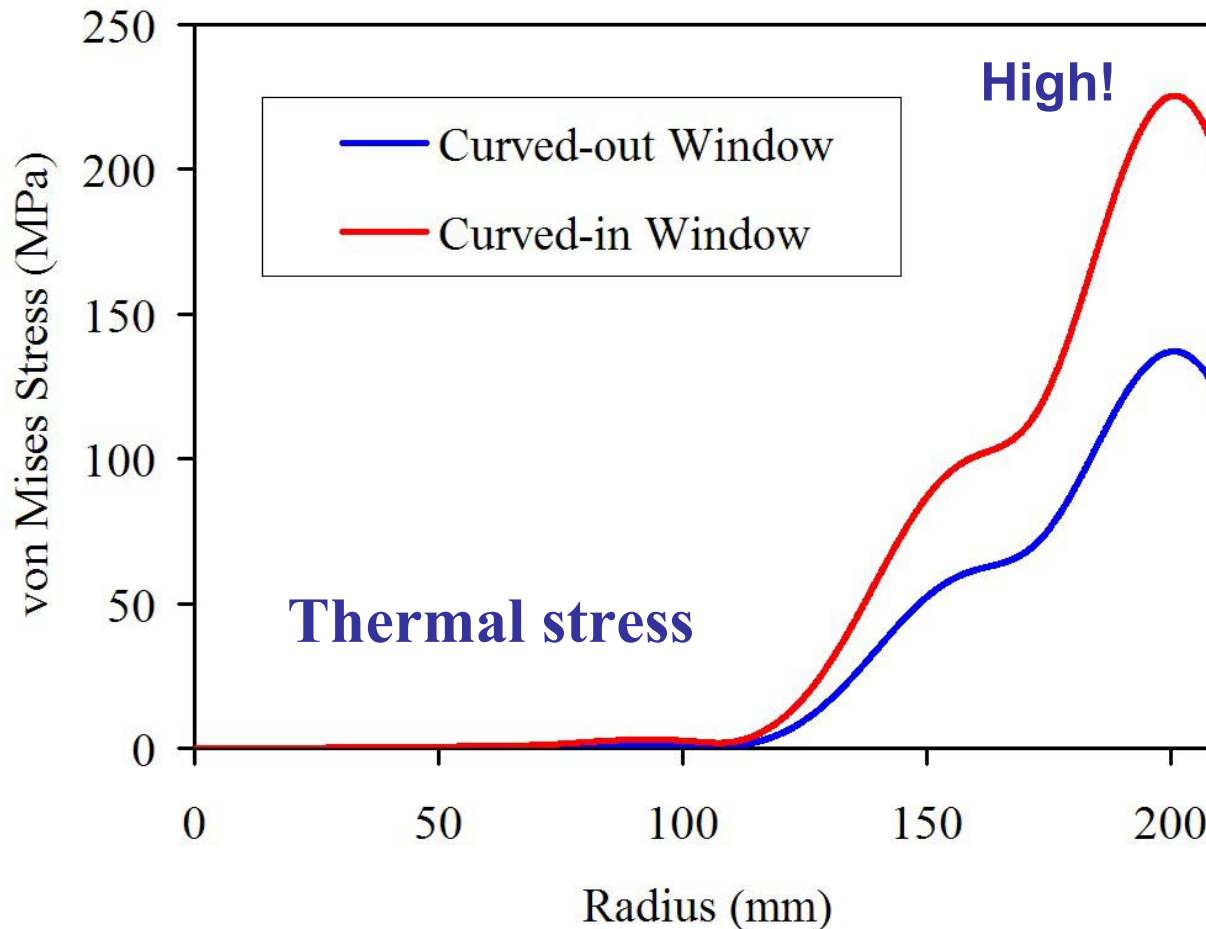
Asymmetric RF Heating (cont'd)

Elastic stress limit of beryllium is 310 MPa
